## HomeSurvey

99 Accacia Avenue, Anytown  
Nottinghamshire NG3 6BL

**Date of Inspection: 3<sup>rd</sup> July 2018**

**THIS REPORT IS A LEVEL 2 SURVEY, CARRIED OUT BY A MEMBER OF THE INDEPENDENT SURVEYORS AND VALUERS ASSOCIATION IN ACCORDANCE WITH THE 'TERMS OF ENGAGEMENT', WHICH HAVE BEEN SIGNED IN AGREEMENT BY THE CLIENT. (A COPY OF THE AGREED TERMS IS APPENDED AT THE END OF THE REPORT).**

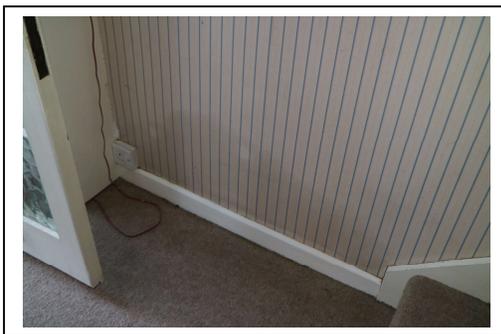
I took readings with a moisture detecting meter to plaster services above skirting boards to all accessible ground floor walls internally. High readings were obtained to localised area of the walls in the entrance hall and kitchen. There is a visible tide mark to the wall plaster in the entrance hall. This indicates dampness, rising up from the ground caused by ineffective damp proof course which has broken down in certain areas. This is an urgent defect that can be remedied. **You should identify the contractor responsible for the installation of the chemical damp proof course and require him to honour the terms of any guarantee, if available, prior to exchange of contracts.**

Tide mark on wall in Hall.

**Alternatively, you are strongly advised to instruct a reliable damp proofing contractor who should be a member of the Property Care Association to carry out an inspection in order to identify the cause and extent of the dampness and provide you with a quotation for remedial works found to be necessary. His recommendation should be implemented in full as soon as possible after purchase with the benefit of a long-term insurance backed guarantee.**

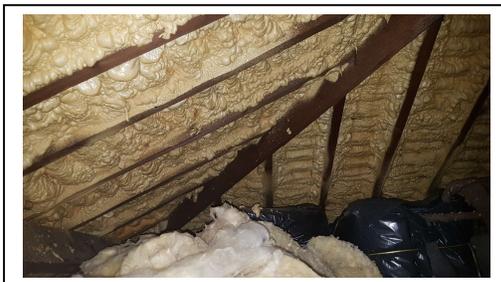
The main roof is covered with slates. Unfortunately, the roof is in poor condition. Foam insulation has been sprayed on the undersides of the slates as seen within the roof space (see photograph). This is not recommended and is a substandard method of "repair." It seems to be effective in preventing rain penetration but can lead to significant problems as it will tend to harbour dampness on adjoining timbers. Many high street lenders will not accept property where this is present as an acceptable mortgage security. This significantly adversely affects saleability. The insulation should be removed as soon as possible after purchase. Removing the insulation frequently damages roof coverings and, often, complete re-covering of the roof is the only option. **You are strongly advised to instruct a competent roofing contractor to provide you with a quotation, prior to exchange of contracts, for the complete recovering of the roof. This should be undertaken as soon as possible after purchase.**

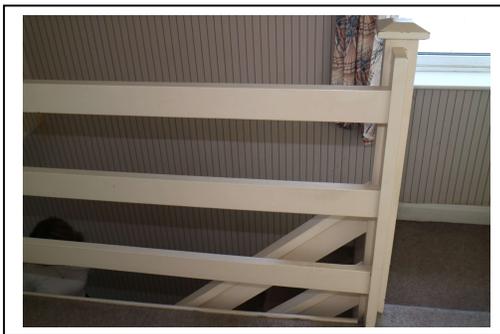
The staircase is of timber construction. The staircase is in a satisfactory condition. Unfortunately, the gaps between the balustrading on the staircase and landing are too wide. This represents a significant safety hazard to small children who could fall through the gaps. Adaptions need to be made to ensure that the gaps between the balustrading do not exceed 10 centimetres. **This is an urgent defect that needs to be remedied as soon as possible after purchase in the interest of personal safety.**

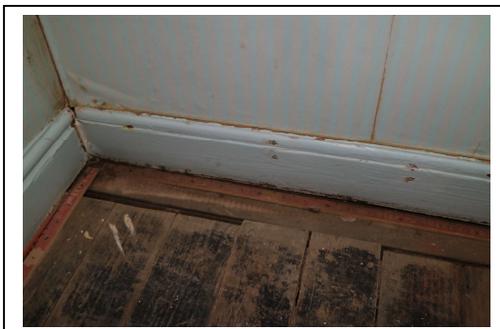
Skirting boards and architraves are of painted timber. These are generally in a satisfactory condition although I note that there are gaps between the skirting boards fixed to the front, left and right-hand walls in the front single bedroom. Again, this indicates past movement of the front wall.

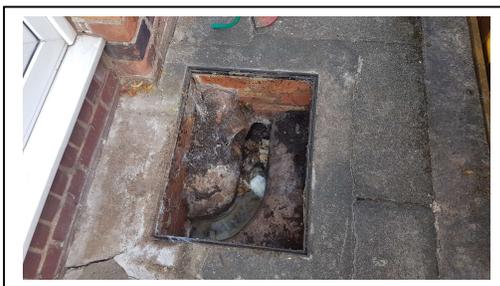
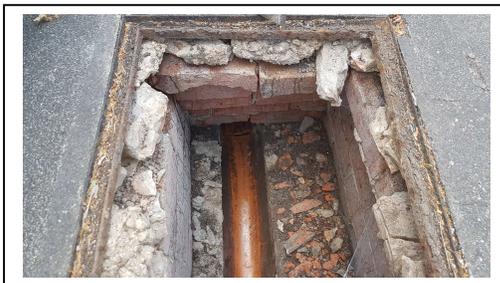
The mains drainage is available and connected. Two inspection chambers were located. The first is positioned in the path in front of the house. The second is positioned in the path that runs down the left hand side of the house adjacent to the kitchen door. Both of the lids were lifted. The half round drainage channels in the first chamber are clear with no evidence of flooding or blockage. Unfortunately, the brick lining to the front chamber is poor condition. Brick debris is building up on the concrete benching adjacent to the drainage channels. This is likely to cause blockage. The rear inspection chamber is, unfortunately, completely blocked with sewage. Whilst this could be caused by a minor blockage, the possibility of more serious defects such as a fractured drain run cannot be ruled out - especially bearing in mind that the property has been affected by coal mining subsidence. **Further investigations are required. You should instruct a reliable drainage specialist to make the underground drainage system the subject of a closed circuit tv scan, in order to confirm the condition. They should provide you with a quotation prior to exchange of contracts for any repair works found to be necessary to include re-building of the brick lining in the front chamber and his recommendation should be implemented in full as soon as possible after purchase with the benefit of a guarantee.**
