HomeSurvey

99 Accacia Ave, Anytown, Nottingham, NG9 1GS

26th July, 2011

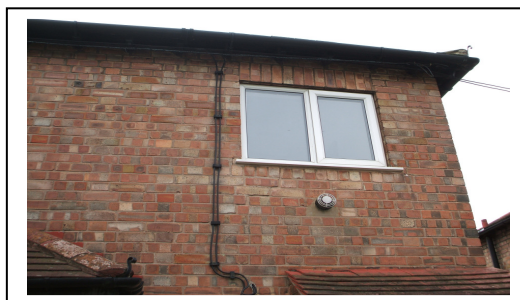
The property has been affected by past movement as may be seen, internally, by certain door openings which are slightly out of square and, externally, by the window opening to the third bedroom which is racked and with distortion to the brickwork beneath this window (see photo below). Such movement would appear to be of a long standing and non progressive nature and is, in my opinion, characteristic of past coal mining subsidence damage. It should not, in my opinion, adversely affect either value or future resale potential. No further investigation is considered necessary although a mining report should be obtained and your attention is drawn to my comments in Section 12.

There is some distortion to the brickwork beneath the rear single bedroom window on the rear elevation as indicated in section 4 but this is not considered to be significant.

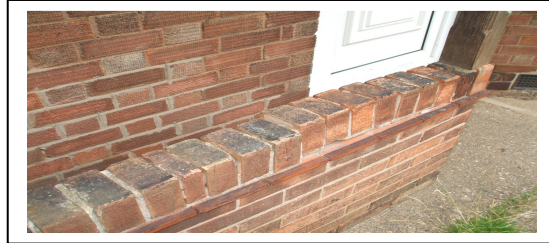
There is a 4 ½ inch brick wall in front of the front door that supports the timbers that carry the canopy roof. (See photo below.) Several of the bricks on the top course of this wall are loose and therefore pose a safety hazard. These need to be re-bedded/repointed in cement mortar and this should be undertaken as soon as possible after purchase.

- **Rebuild loose brickwork to the wall that carries the canopy porch in front of the property.**
- **Repair loose stonework to front boundary wall.**
- **Eradicate rising dampness affecting main walls.**

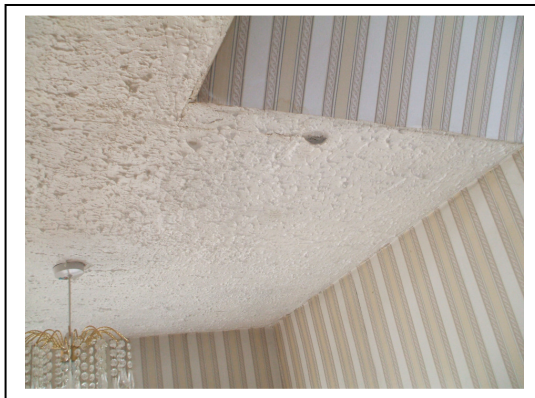
Ceilings as seen within the roof space are made of plasterboard decorated with emulsion paint. Most of the ceilings have a textured coating known as Artex. The Artex finish is very heavy in certain rooms. (See photo below) Artex finishes have generally lost popularity in recent years. You should note, however, that Artex applied prior to 1986 can contain particles of Asbestos. Consequently, the removal of Artex should only be undertaken by a specialist contractor and the cost of such works can be quite high. Under no circumstances should you attempt to sand off the Artex. If you would like to improve the appearance of the ceilings, it would be probably be more economical to have these over boarded and re-skimmed prior to redecoration.

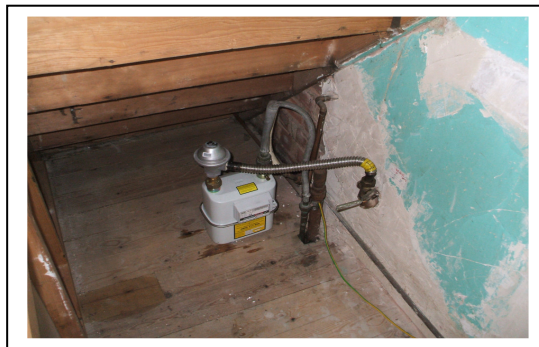
Mains gas is available and connected. The gas meter is located in the under stairs storage cupboard. Part of the gas piping to the meter is made of lead (see photo below). Although I did not see a current problem, lead pipes can distort over time and this may result in gas leaks. You should plan to have these replaced in the future.

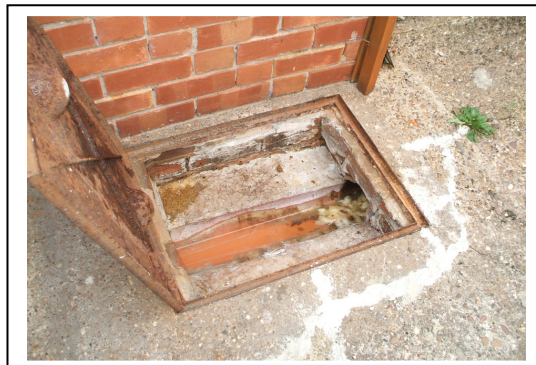
There are two inspection chambers within the curtilage of the property. The first is positioned approximately halfway down the shared driveway. The second is positioned at the back of the shared driveway. Both lids were lifted. The drainage channels are only about 4 inches below ground level i.e. are very shallow. There is evidence of a slight blockage in the rear channel. Liquids are pooling in this channel which may indicate a slight back fall. Rat droppings could be seen on the benching. (See photo below) The shallow depth of this drain run means that it is extremely vulnerable to damage by vehicles. According to the neighbour, the drains become blocked quite frequently. You are, therefore, strongly advised to instruct a reputable drainage specialist to make the underground the subject of a close circuit TV scan in order to assess its condition and provide a quotation, prior to exchange of contracts for any repair work found to be necessary. Your Legal Advisor should advise as to who is responsible for any works on this shared drainage system.

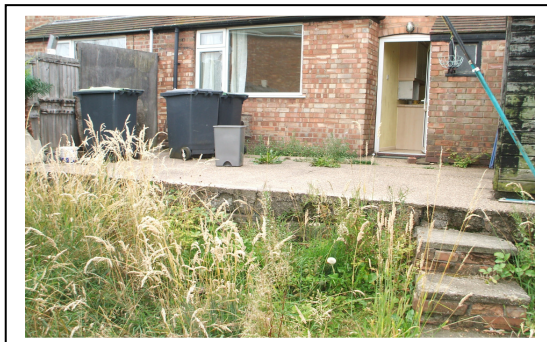
There is no wall at the back of the rear patio. This is a safety hazard. The steps leading down from the patio are extremely uneven and this poses a tripping hazard.

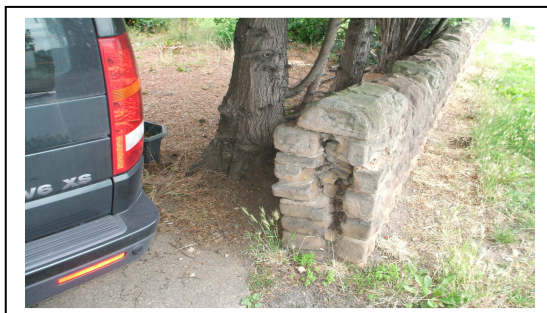
The end section of the front stone boundary wall has been damaged and the stonework is loose so presenting a safety hazard particularly to children (see photo). This needs to be rebuilt to make it safe and this should be done as soon as possible after purchase.
